BAR TROUBLESHOOTING CHART

APPLICATION GUIDE

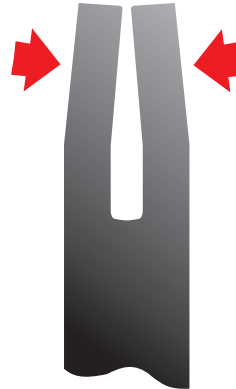
CLOSED-IN RAILS

Cause:
Force has been used, when cutting attachment has been pinched in cut.

Result:
Chain jams.

Remedy:
Open up bar groove.

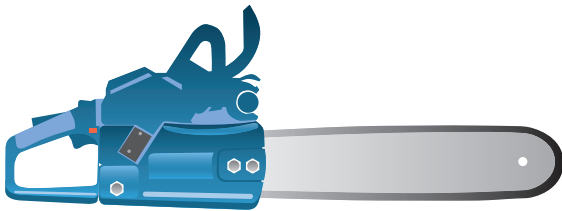
CORRECT BAR TENSIONING

- 1) Loosen guide bar mounting nut.
- 2) Tighten tension screw until the bottom of the side links just contact the bottom of the guide bar rails.
- 3) When chain is tensioned correctly, it should pull freely around guide bar.
- 4) Hold bar tip upwards and tighten mounting nuts.

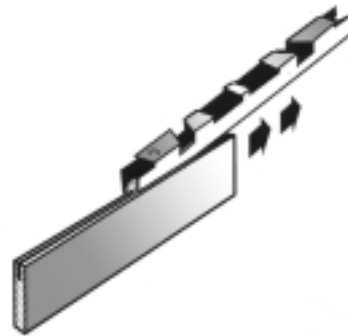
GROOVE CLEANING

- 1) Clean guide bar grooves regularly.
- 2) Clean oil holes.

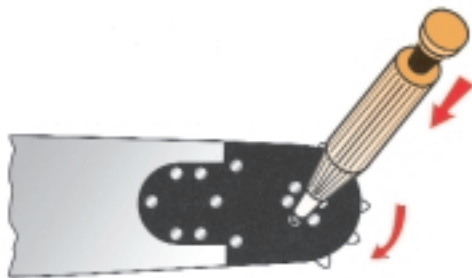
LUBRICATING NOSE SPROCKET

- 1) Clean out grease hole before inserting grease nozzle.
- 2) Rotate the nose sprocket while pumping grease into bearings.

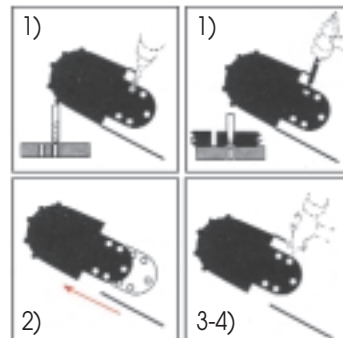
REPLACING SPROCKET NOSE ASSEMBLES

- 1) Punch or drill rivets out.
- 2) Remove damaged nose.
- 3) Replace with new nose.
- 4) Peen rivets carefully. Do not hit bar body.
